# LIMITED FUNGAL INSPECTION REPORT

ONSITE PRO RESTORATION

Prepared For:  
Your Address . City , CA 90293  
**Project No. 5555555 01/01/2025 10:20AM**

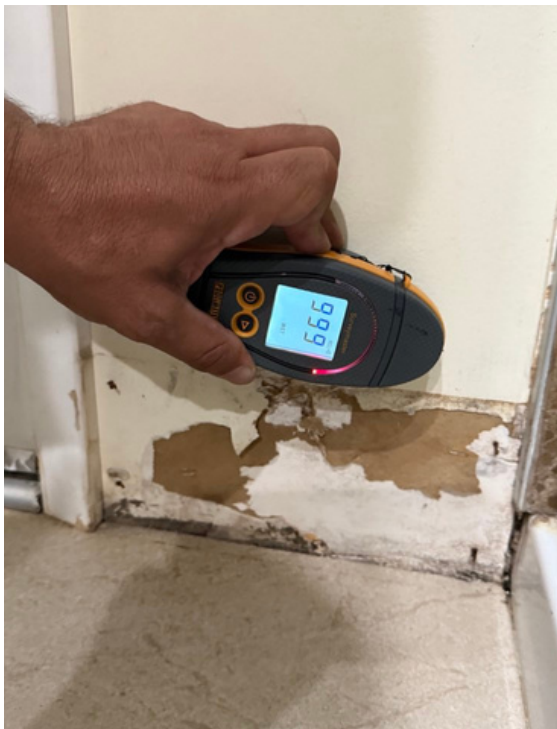
Side of the stand-up shower showed high moisture readings and visible contamination along the lower portion of the wall.

- You already mentioned shower wall moisture and visible contamination — this could be the growth site feeding these spores into the air.

- Hidden water damage behind the shower wall (moisture readings confirmed) supporting Aspergillus/Penicillium and Ulocladium growth.
- Damp fabrics, carpets, or stored items in the Clothing Bedroom acting as spore reservoirs.
- Insufficient ventilation in bathrooms allowing condensation molds like Cladosporium to grow.
- Particles being redistributed by foot traffic, cleaning, or HVAC, keeping spore levels elevated in multiple rooms.

The findings suggest that remediation is necessary to address the elevated mold spore levels. To determine the source of the problem, a more thorough inspection of the residence is recommended. This may involve removing baseboards in certain areas to check for discoloration or other signs of mold growth behind them.

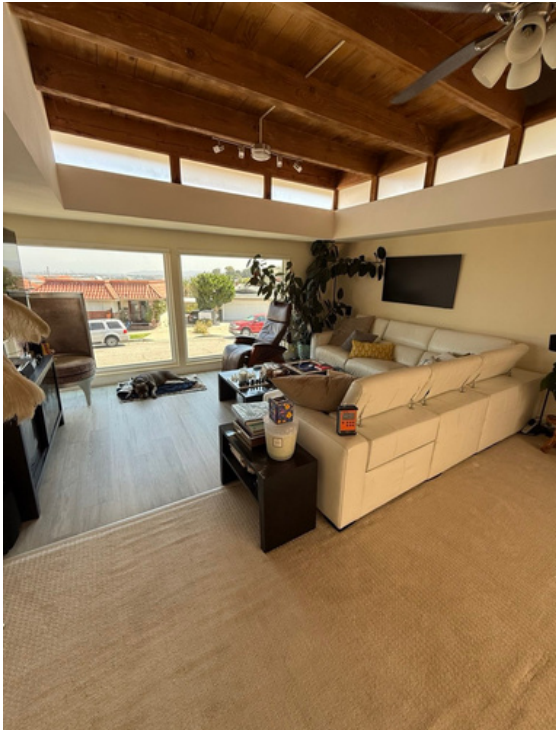
Living Room

- PM2.5: 38.9  $\mu\text{g}/\text{m}^3$  → Unhealthy for Sensitive Groups
- Higher PM1 and PM4 indicate a mix of very fine and slightly larger particles – possibly from cooking emissions, dust, or HVAC system recirculation.

Recommendation: Air purifier, inspect HVAC filters, limit activities that create fine particles indoors.

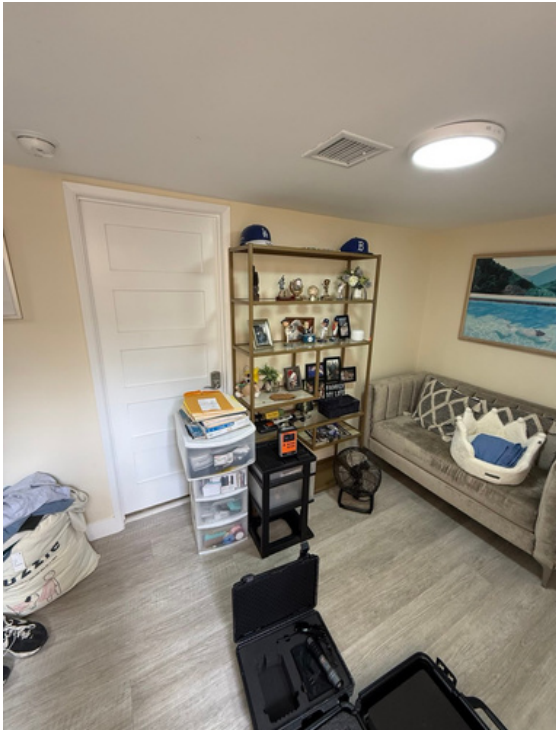
**Downstairs Hallway**

- PM2.5: 33.0  $\mu\text{g}/\text{m}^3$  → Upper Moderate (close to unhealthy threshold)
- Consistent particle sizes suggest a steady background source like settled dust being disturbed.

Recommendation: Vacuum with HEPA filter, improve whole-house airflow.

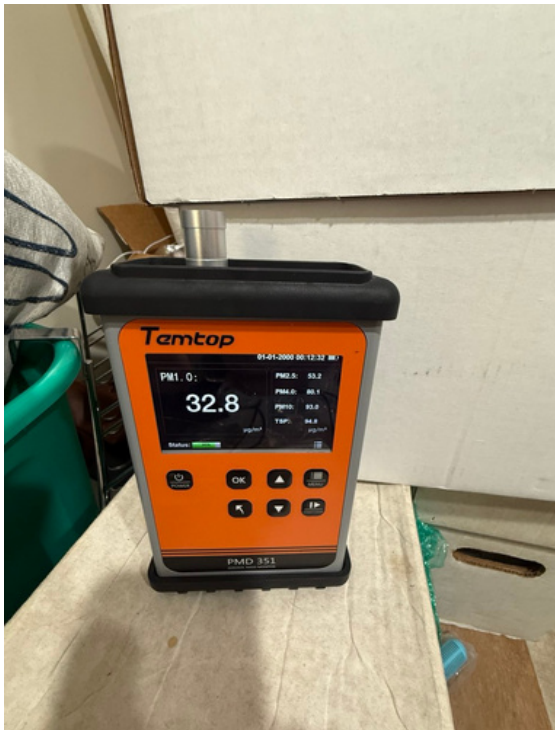
**Clothing Bedroom**

- PM2.5: 53.2  $\mu\text{g}/\text{m}^3$  → Unhealthy for Sensitive Groups (EPA: >35 is elevated)
- Likely indicates fine particle pollution from dust, fibers, or possible mold spores.
- PM1 and TSP are also high, suggesting smaller respirable particles are dominating.
- Possible sources: stored clothing releasing fibers, poor ventilation, or dust build-up.

Recommendation: Deep clean, improve air filtration, consider a HEPA air purifier.

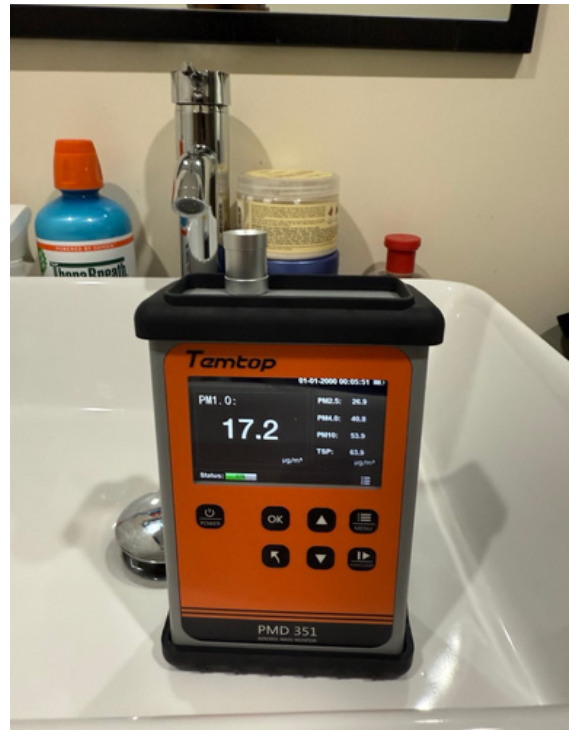
**Downstairs Bathroom**

- PM2.5: 26.9  $\mu\text{g}/\text{m}^3$  → Moderate (not ideal, but not severe)
- PM10 and TSP are high for a bathroom, possibly from lint, skin cells, or moisture-related particles.
- Lower PM1 than bedroom, meaning fewer ultra-fine particles.

Recommendation: Improve exhaust ventilation, ensure no hidden mold growth.
